Review of Instrument Unit Emergency Detection System at IBM/Huntsville on September 1 Case 330

October 12, 1966 DATE:

T. F. Loeffler FROM:

#### MEMORANDUM FOR FILE

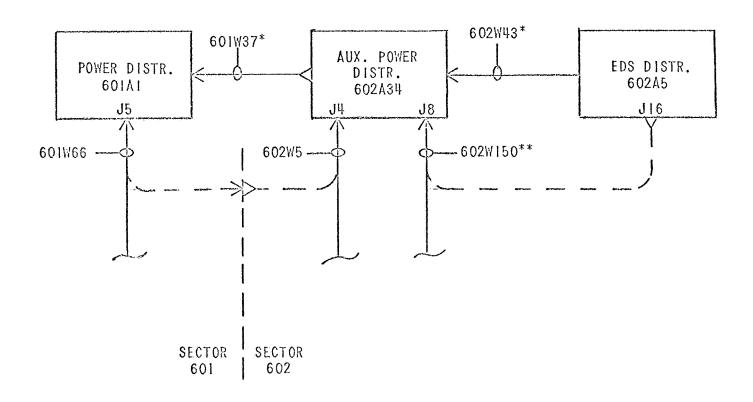
# BLOCK DIAGRAM REDUNDANT POWER TO EDS UCN 4853

- 6. IU 201 Problems and Their Solutions: In the Control Signal processor excessive vehicle vibration (during SA-201) caused noisy signal in the gyro circuits. This problem was solved by inserting a low pass filter into the circuit. A harmonic distortion problem in the rate gyro circuits was solved by changing of scale factors.
- 7. Single Point Failure Problem Areas; There is only a single cable (and connector) each leading from the TU Batteries to the Power Distributor, from there to the Auxiliary Power Distributor, and then to the EDS Distributor, as shown in Figures 9A & B. Proposed new cable branches in parallel with the present ones would provide the desired redundancy.

\* NEW CABLE BRANCHES

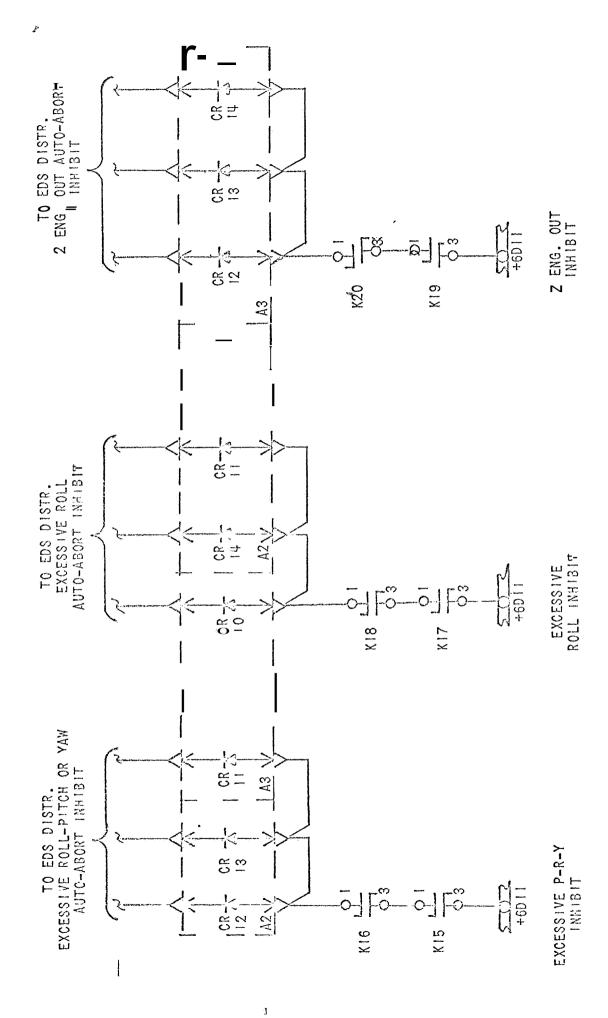
PRESENT METHOD

In the IU Control Distributor, there is a single path each, in the two "excessive rate inhibit" and the "two-engine out inhibit" circuits, as shown in Figure 10A. The proposed redundancy shown in Figure 10B would provide the desired dual paths.
